**West Coast Lifelines
Vulnerability and Interdependency Assessment**

**Supplement 12:
Westland District Council
Lifelines Assets**

West Coast Civil Defence Emergency Management Group

August 2017

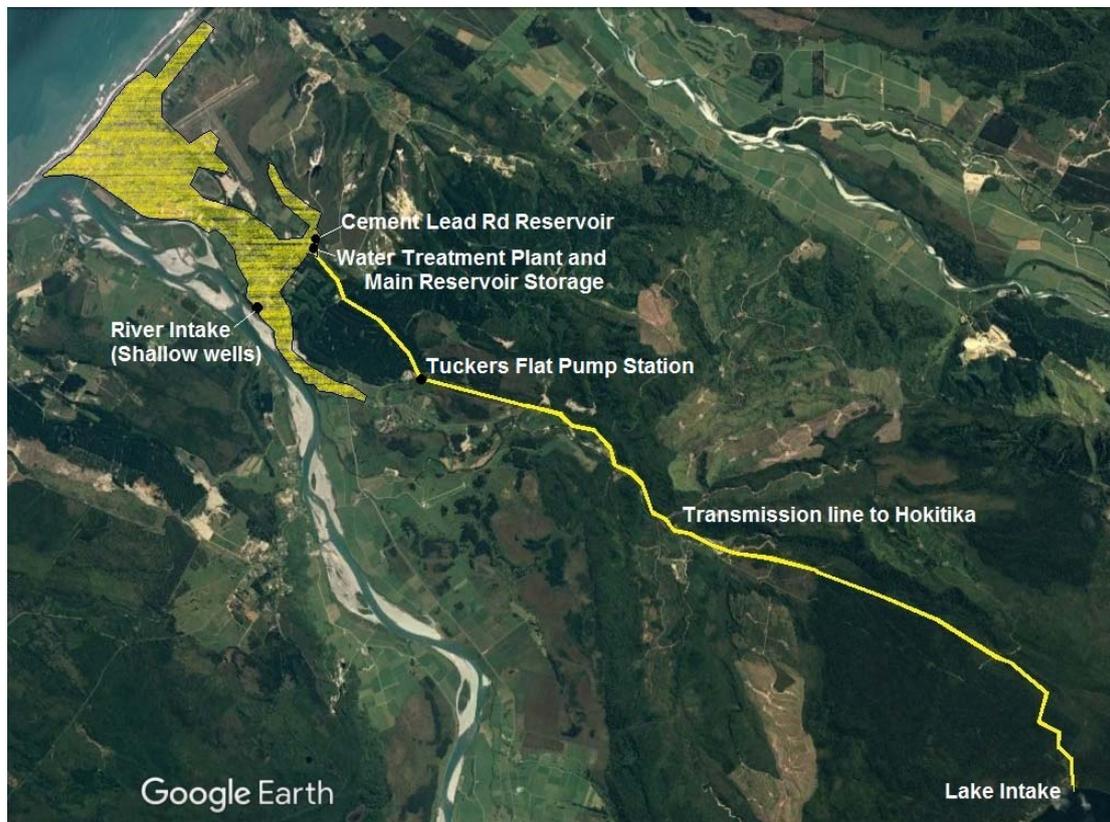
Figure 3.1: Hokitika Water Supply

- Transmission pipeline failure. Damage is likely to the transmission line between the lake intake and the Pine Tree Road reservoirs with breaks likely in weak sections and at bridge abutments;

- Failure at the reservoirs. There are no automatic burst control valves on the pipelines from the reservoir sites or between the nine tanks making up the treated water reservoirs to prevent the reservoirs draining due to pipe and/or reservoir failures caused by the earthquake. Pipe connections between the reservoirs are thought to be rigid and damage at the reservoir entries is probable.

- Much of Hokitika is located on geologically recent alluvial soils, with some ground settlement and distortion to be expected. Some liquefaction could be expected in the area bounded approximately by Revill Street, Tudor Street and Fitzherbert Street. The soils are firmer in the area north of approximately Stafford Street and east of Fitzherbert Street and structures in this area are likely to sustain less damage than in other parts of Hokitika. From Table 3.1 it can be seen that 78% of the pipework is PE and PVC which performs reasonably well in earthquakes. However 18% of the distribution network is asbestos cement (AC) pipe including the trunk main from the reservoir site. AC is rigid and performs poorly in earthquakes. While there are likely to be some breaks in the PE and PVC pipework a significant number of breaks could be expected at junctions and connections in the AC pipework. The greatest number of breaks is likely in AC pipework in liquefiable areas. A significant number of breaks could lead to loss of water and pressure in the distribution system.

- Investigate in more detail the potential of earthquakes to cause movement of WDC reservoirs, in particular the Hokitika reservoirs. Consider installing earthquake burst valves at reservoirs.
- Prepare a formal plan for recovery of WDC water supplies after a major natural disaster.

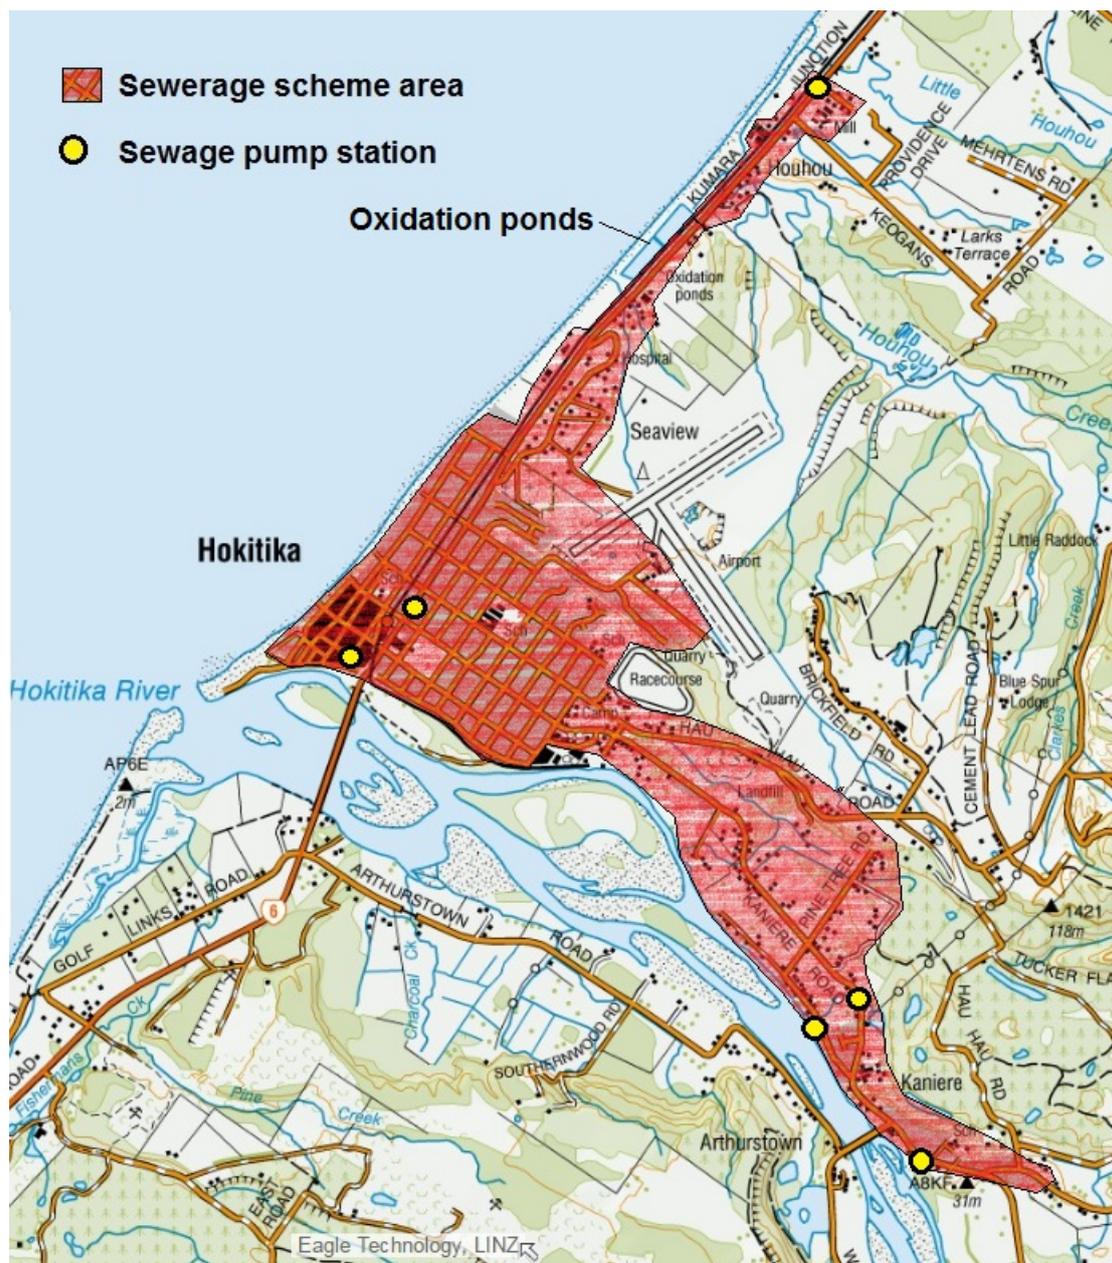
Figure 4.1: Hokitika Sewerage Scheme

- Most of the sewer network (69%) is constructed from rigid materials: asbestos cement pipe (63%) or concrete (6%), which are prone to failure when exposed to strong ground shaking. The rest of the network (31%) is PVC or PE pipe which is likely to have fewer failures in a major earthquake. Failure of rigid materials and some PVC and PE pipe can be expected at junctions and at connections with structures like manholes and pump stations. Movement of pipes might affect pipe grade. Failure rate and change of pipe grade would be greater in areas of liquefiable and soft

- Power would probably be lost after a major earthquake and would not be reinstated for some time. This would lead to surcharging and ponding at some pump stations.
- There could be damage at the oxidation ponds site including failure of the aerial discharge pipe into the ponds and the aerial ocean outfall pipe due to shaking and also lateral spreading of the pond embankments particularly the northeast end.

- Damage to the electrical and control systems in the pump stations' cabinets in Sewell Street and possibly also in Fitzherbert Street due to flooding.
- Inundation of pump stations by flood water carrying sand, silt and debris into the wet wells.
- There might be some storm surge damage to the aerial ocean outfall pipe and possibly the oxidation ponds.
- Wind damage might cut grid electricity so that pump stations could not operate, leading to surcharging.

- Damage to the electrical and control systems in the pump station cabinets in Sewell Street and possibly also in Fitzherbert Street.
- Sand and debris carried by the tsunami wave might enter the pump station wet wells.
- Inundation of the oxidation ponds, with seawater partially filling them with sand and gravel from the beach. The embankment on the northern end might be washed out. All above ground assets including the aerial discharge pipe into the ponds and the aerial ocean outfall pipe might be destroyed.

- Assess options for protecting pump station power supply and control cabinets componentry from inundation (tsunami or flood).
- Review options for minimising damage to the Hokitika oxidation ponds from a damaging tsunami.
- Undertake an assessment of public health risk posed by potential sewage surcharging at pump stations leading to overland flow and ponding. Identify solutions as required including a formal plan for sewage disposal after a major natural disaster.

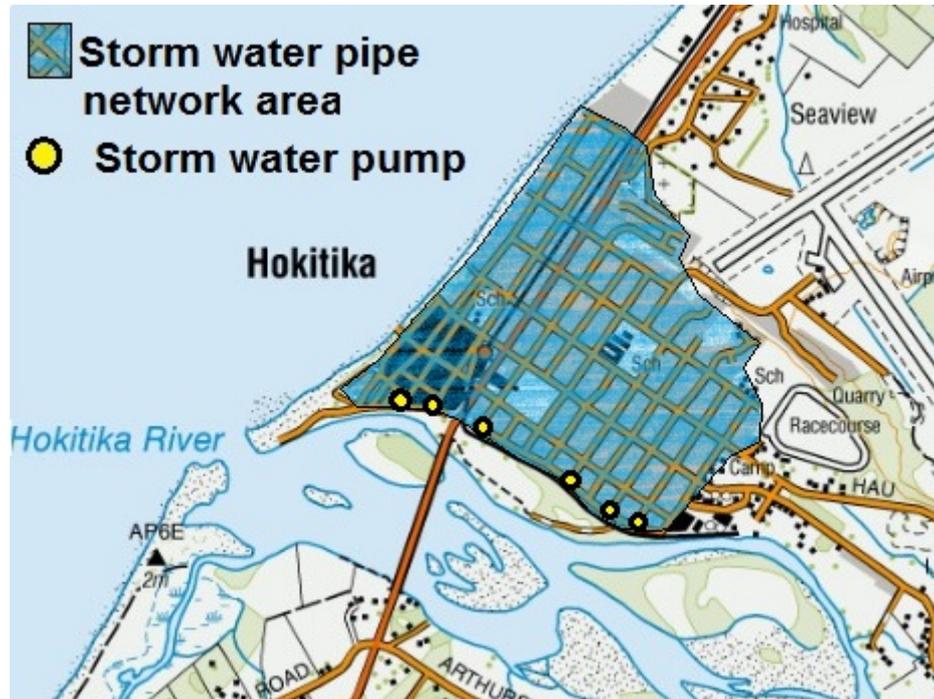
Figure 5.1: Hokitika Storm Water Scheme

- Rigid pipe materials make up almost 80% of the Hokitika storm water network. Significant pipe and joint failure as well as failure at connections to manholes and pump stations would be expected particularly in areas of soft or liquefiable soils, i.e. the area bounded approximately by Revell Street, Tudor Street and Fitzherbert Street.
- Power would be likely to be lost after the earthquake and might not be reinstated for some time. If there were a major storm in this period then generators would need to be brought into each pump site.

- In the event that the Hokitika stopbanks were breached all six storm water pumps might be inundated and damage could be expected to the electrical and control systems.

- Breaching of the stopbanks would be likely to lead to scour damage.
- Inundation of storm water might wash sand, silt and debris into storm water drains and wet wells.

- In the scenario presented in *Supplement 4* the pump station on Sewell and Tancred streets would suffer impact damage and inundation while the pump station on Bealey Street would be inundated. Inundation could damage the electrical and control components at the pump stations and wash sand and debris into wet wells and storm water drains.
- There might be some scour damage to the storm water stopbanks.
