**West Coast Lifelines
Vulnerability and Interdependency Assessment**

Supplement 4: Tsunami

West Coast Civil Defence Emergency Management Group

August 2017

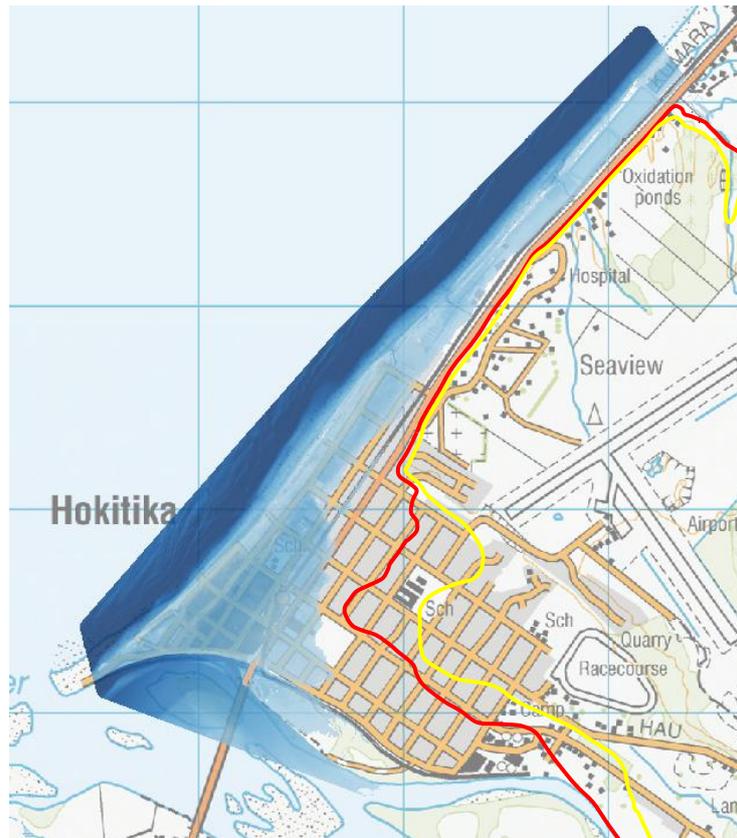
Possible areas of Hokitika inundated with 500 year recurrence interval tsunami (7.2m run-up at shore) No allowance for inundations from the river

See 3.1 for key and limitations

As the ground level in the CBD area is as low as about 2m, inundation depths are likely to be large: 4 – 5m is quite possible in the lower parts of the CBD. Ground levels are about 2m higher at the north end of town, and water depths are likely to be more like 2m. The tsunami wave that affects this degree of flooding will also result in scouring of the beach ridge and the river stopbank. While this will allow more of the flood waters to drain, it also exposes the area to repeated flooding with lower tsunami waves following the largest wave.

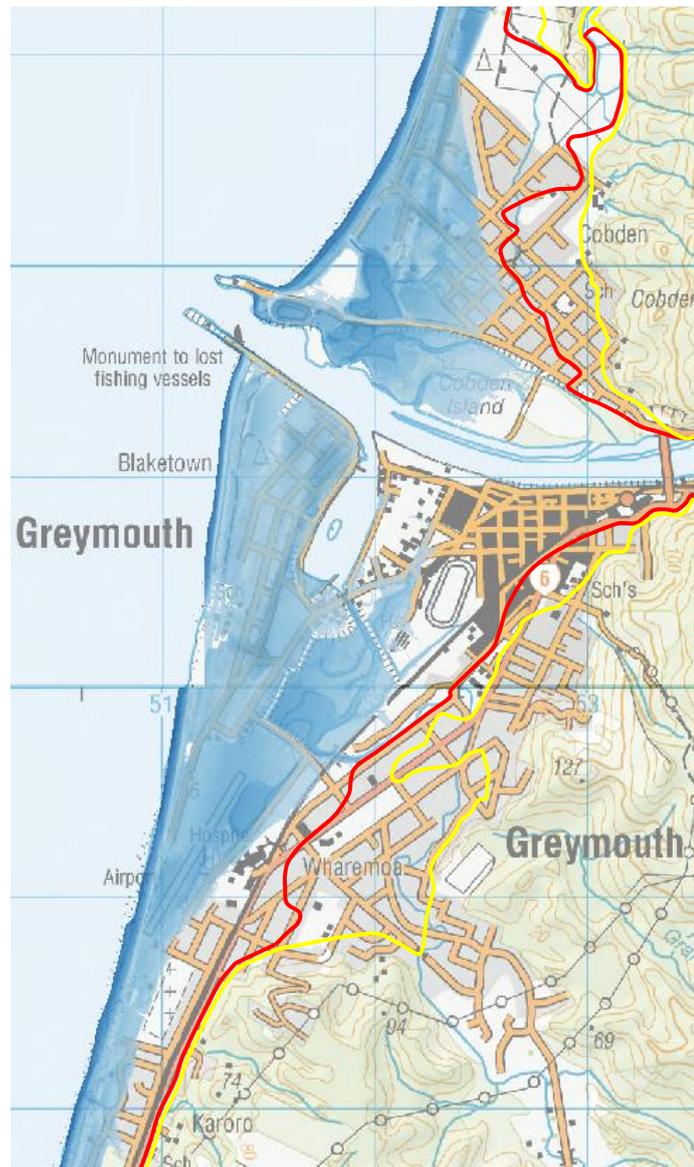
Yellow line is edge of yellow evacuation zone

See 3.1 for key and limitations

- Flooding with salt water. Depths will vary from very little at the eastern extremity to 3 - 4m in lower parts of Blaketown.
- Scour of ground on embankments and slopes and around buildings wherever water velocities are high enough.
- Sand and gravel washed from the beach and redeposited throughout parts of the flooded area.
- Non-fixed items such as vehicles and building contents floated throughout the area and in areas of sufficient velocity causing impact damage to structures.
- Lightweight buildings which are not securely fixed to foundations will be washed away throughout the area and many timber framed buildings in the Blaketown area will be destroyed. Structural damage is likely to remaining buildings from water pressure, scour and impact.
- Large amounts of debris will be left throughout the affected area.

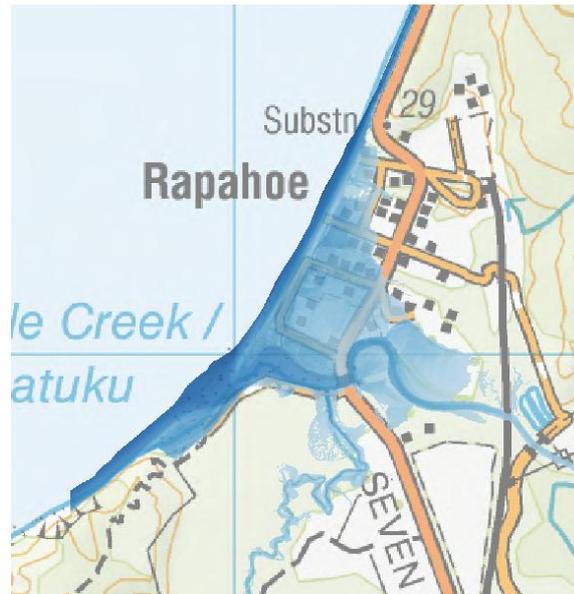
Possible areas of Rapahoe inundated with 500 year recurrence interval tsunami (7.2m run-up at shore) No allowance for additional inundation from Seven Mile Creek

See 3.1 for key and limitations

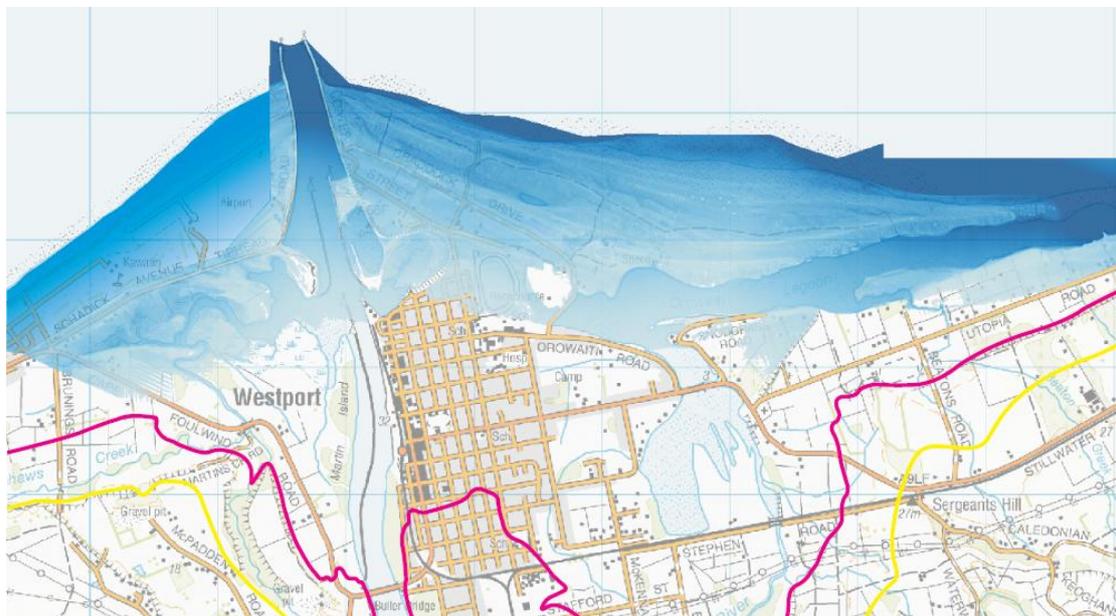
Figure 3.4: Westport Inundation

Possible areas of Westport inundated with 500 year recurrence interval tsunami (9.4m run-up at shore) No allowance for additional inundation from river or Orowaiti estuary. See 3.1 for key and limitations

| | Location | Damage |
|---|---|---|
| 5 | Westport | Two thirds of the town is flooded. There is damage and scour along the Buller River and around Orowaiti Lagoon. SH 67 Buller bridge is little affected but Orowaiti bridge is. Utopia Rd (4km long) east of Orowaiti is flooded. |

Westport has been modelled with tsunami coming over the open shoreline only. Westport is exposed on three sides: tsunami overtopping the beach directly at the north end of the town, overflowing from the Buller River on the west and from the Orowaiti estuary on the east, and therefore this inundation area is likely to be under-predicted in at least some areas. Flow patterns are likely to be complex.

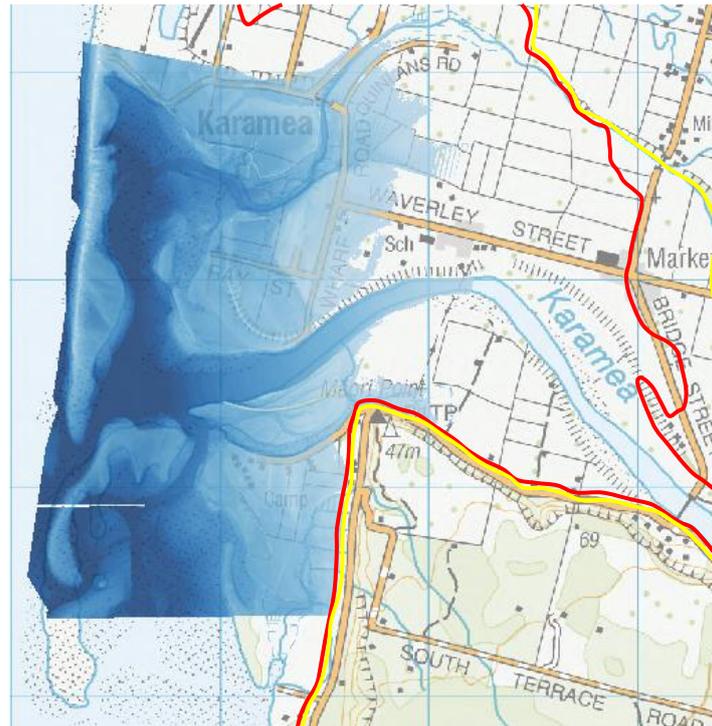
Possible areas of Karamea inundated with 500 year recurrence interval tsunami (7.4m run-up at shore) No allowance for additional inundation from Karamea River

See 3.1 for key and limitations

Beyond the area modelled, the Karamea Highway between Little Wanganui and Karamea runs for 11km at between 0.1 and 0.5km of the shore, and most of this length can be expected to be inundated. The substation part way along this length at Kongahu is about 0.4km inland and is also likely to be within the inundation zone, as is the main power line to the district.
