**West Coast Lifelines  
Vulnerability and Interdependency Assessment**

**Supplement 6:  
Transportation Lifelines Assets**

West Coast Civil Defence Emergency Management Group

August 2017

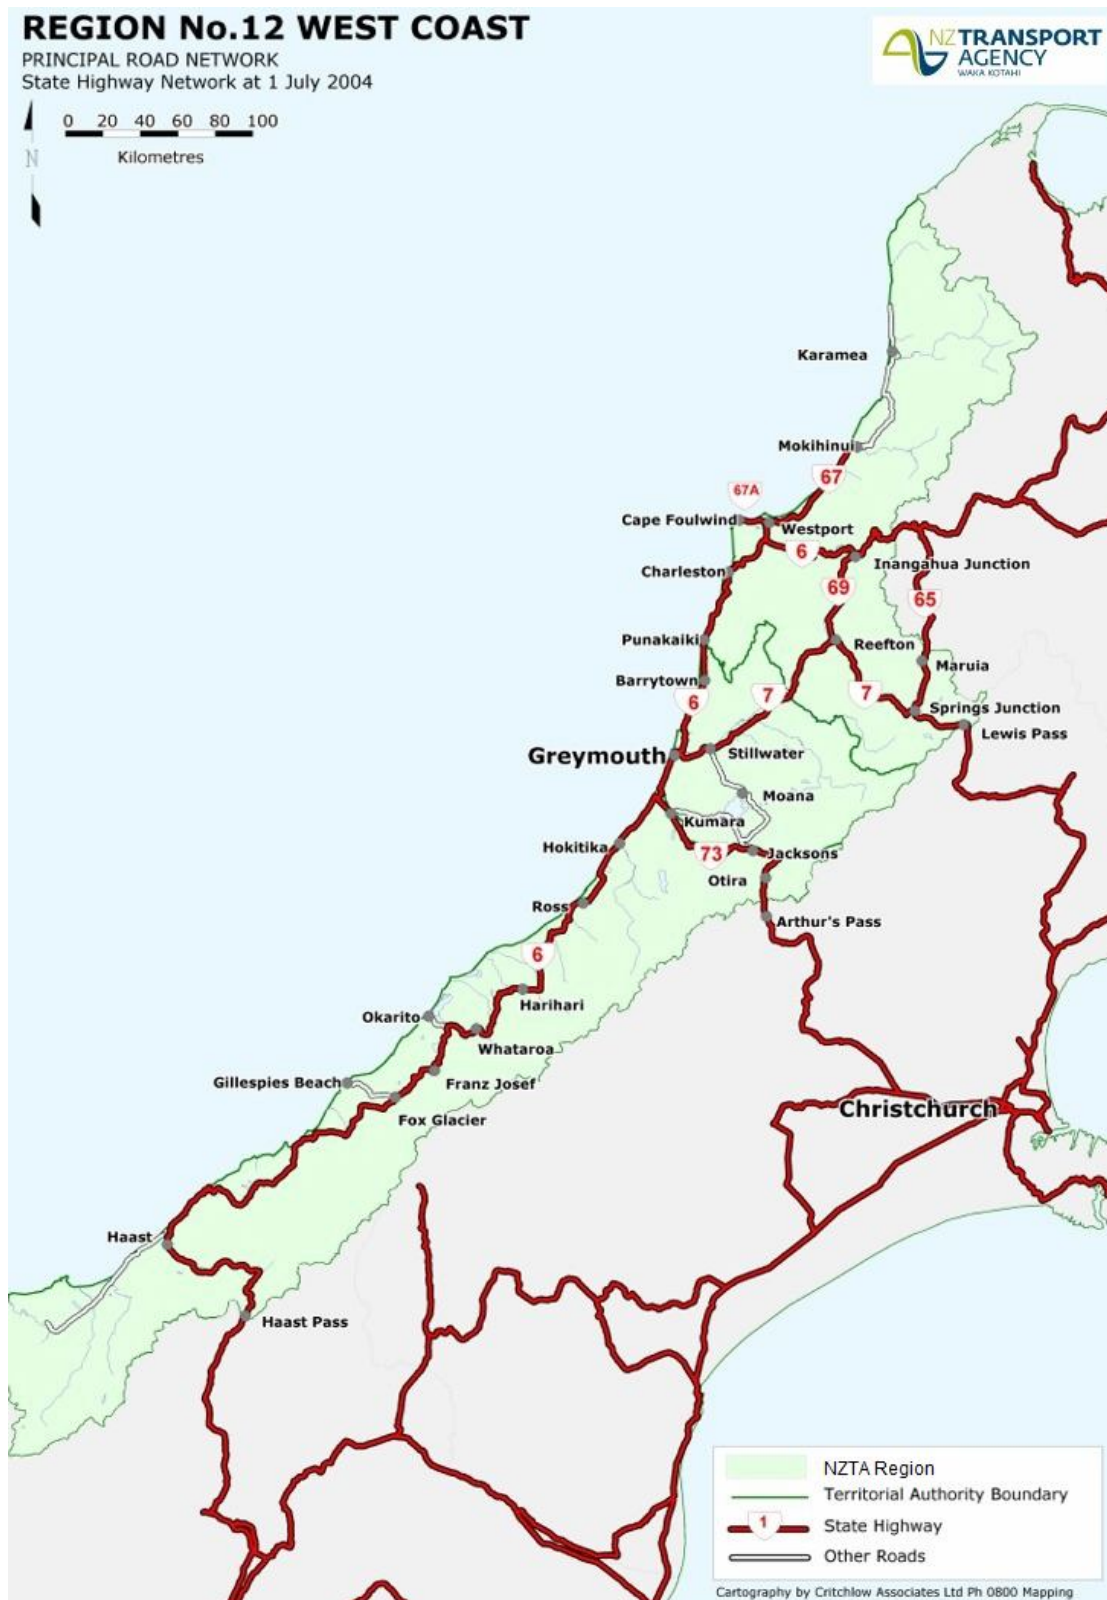
Figure 2.1: West Coast State Highway System

The West Coast Region’s road system is characterised by its length, low traffic volumes, frequently mountainous or hilly terrain with high rainfall and the many rivers and streams that cross the main routes. Figure 2.1 shows both State Highways and district roads. There are only four links to the rest of the South Island, all State Highways, with three of them crossing mountain passes. Within the northern part of the region there are some alternative routes such as the coastal and inland routes between Westport and Greymouth, and the Upper Buller Gorge and Maruia Valley routes between Reefton and Murchison. On the other hand, South Westland is characterised by a single State Highway without any alternative linking all the communities between Ross and Haast as well as those on the WDC road south of Haast. This combination of relative lack of redundancy, low traffic volumes holding back major upgrades, and the challenging environment makes the road system particularly vulnerable to natural hazards.

The West Coast road and rail transport systems are presented in Figures 2.1 and 3.1, which also show the four State Highway road links and the railway link out of the region.

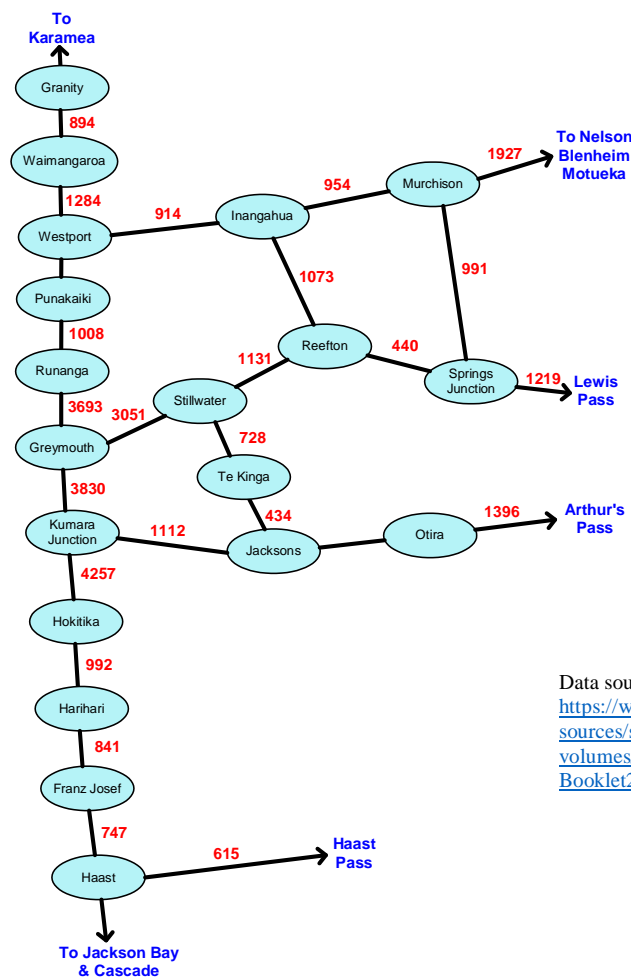
Figure 2.2: Annual Average Daily Traffic Volumes (NZTA for 2015)

Traffic volumes from NZTA for the State Highways in the region for 2015 are provided in Figure 2.2. Similar traffic volumes use the Upper Buller, Lower Buller, Maruia Valley, coastal and Reefton – Inangahua roads. Arthur’s Pass carries a similar volume as the Lewis Pass, but over twice as much as the Haast Pass.

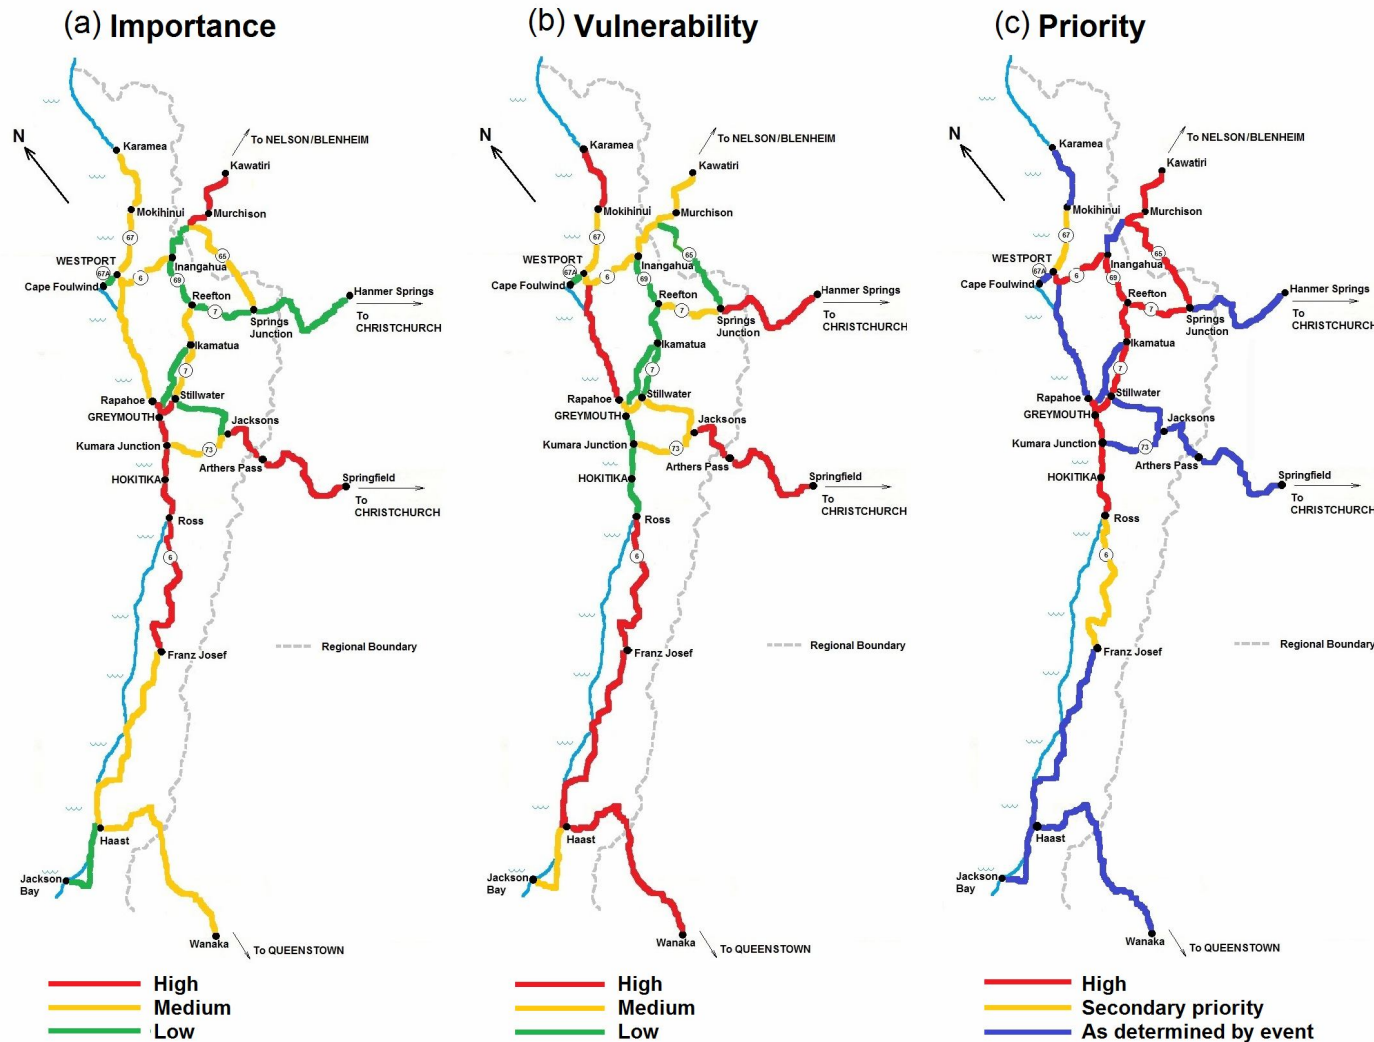
Figure 2.4 Road Network Importance, Vulnerability & Priority

The importance and vulnerability of the 26 road links are shown on Figure 2.4 (a) & (b). This gives some idea of these aspects, but then the question is what do they mean in terms of resilience of the network and recovery from a large natural disaster. Although the previous two sections have considered 26 individual sections of road, from the point of view of the region's resilience it is important to think of the road network as a whole. One approach would be to take the high importance routes and upgrade them to reduce their vulnerability. On paper this seems logical, but when we consider which routes are most important, we see that several of them are also very vulnerable with multiple susceptible areas on long lengths, and there are also discrete route lengths separated by lower importance roads. If some roads are taken as strategic to link the main centres, as has probably been done in making SH 6 arterial throughout its length, this also presents problems as some of the links are in the high vulnerability group, whereas there are alternative links less likely to be damaged and easier to repair. What we have done, therefore, is to consider the two maps of Figures 2.4 (a) & (b) together and select key components of the network as priority routes. These are shown in Figure 2.4 (c).

The intention with these priority routes is to provide a spine of roading that is less likely to be damaged and easier to re-open and repair, and which links the main population centres and the region with the rest of the South Island. Our suggestion is to provide a focus on SH 6 from Ross through Hokitika to Greymouth, and SH 7 from Greymouth to Reefton. At Reefton one priority route follows SH 69 to Inangahua and then SH 6 to Westport, and a second follows SH 7 to Springs Junction, SH 65 to Murchison and SH 6 to Kawatiri, with most of these last two links being outside the West Coast region.

The rationale for this choice is:

- The least vulnerable route linking the West Coast Region with the rest of the South Island is north through Murchison and Kawatiri. The other three routes all cross the Alps with high vulnerabilities. There is of course considerable redundancy in the network with these links and a large earthquake or storm event is unlikely to significantly damage all routes at one time. Rather than choosing one of the Alpine passes as a priority route and building infrastructure and planning around that, we suggest it is better to be able to respond to any actual event and use the route that is least damaged and faster to re-open. For instance, an earthquake in the Buller region, such as the 1929 Murchison earthquake, will close the SH 6 route to the north, but should have little effect on Arthur's Pass and none at Haast. Traffic from the Coast can then be directed south and east. Conversely a large Alpine Fault earthquake is likely to have devastating effects on SH 6 in the south, serious impacts on SH 73 over Arthur's Pass but little impact on Lewis Pass or Murchison, and Coast traffic can be directed north. This calls for a route within the West Coast able to access whichever of the outside link roads are open and suitable for traffic.

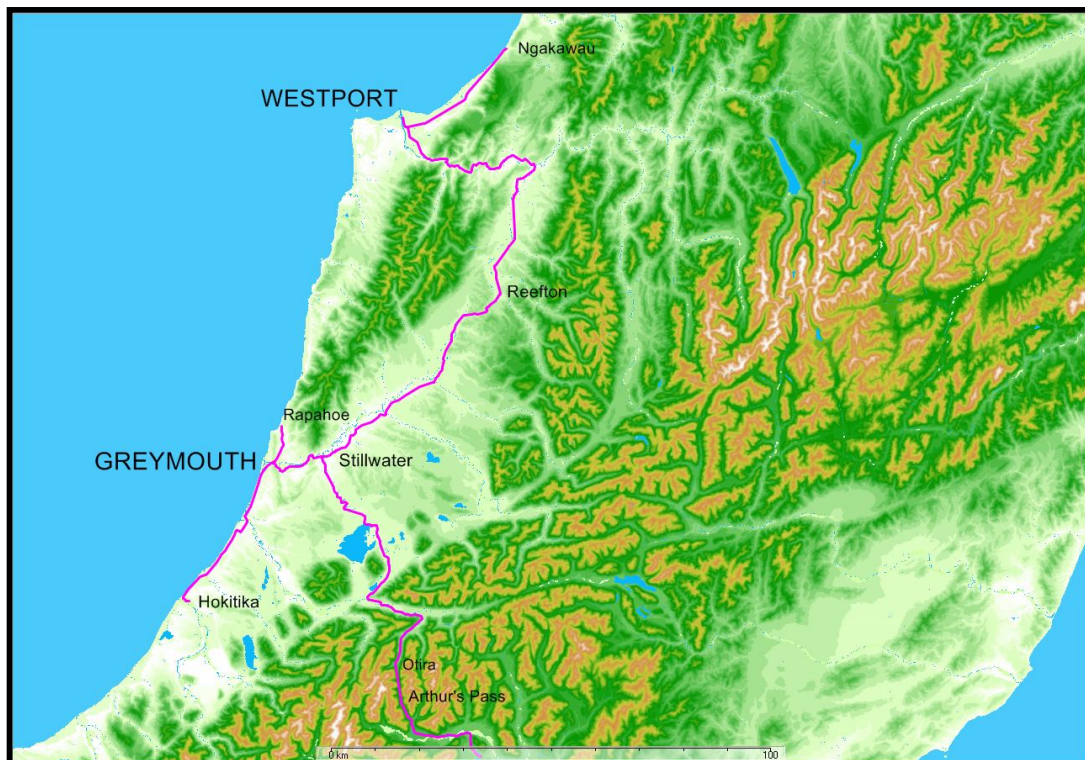
The New Zealand railway network is owned and operated by the state-owned enterprise KiwiRail Holdings Ltd trading as KiwiRail. The West Coast is linked to the national rail network via the Midland Line from Rolleston (Christchurch) and shown in Figure 3.1. At Stillwater it splits to a north line to Reefton, Inangahua, Westport and Ngakawau, while a south line leads to Greymouth, Rapahoe and Hokitika. The line is single tracked with numerous passing loops and it varies considerably in age and condition. The major traffic on the line is coal transport from Ngakawau (Stockton Mine). Westland Milk Products also rails most of its products from the Hokitika factory. The future of the railways is closely linked to these two industries, although the TranzAlpine passenger train is of some importance for tourism. The Rapahoe branch line is currently not in use following closure of the Spring Creek coal mine. If the Hokitika dairy factory were to use alternative transport, the Greymouth – Hokitika branch line would probably close as well. The Midland Line is heavily dependent on coal traffic from Stockton, and if production were to drop significantly, the economic viability of the whole rail network west of Canterbury would be questionable.

**Figure 3.1: West Coast Rail Network** Map provided courtesy of KiwiRail

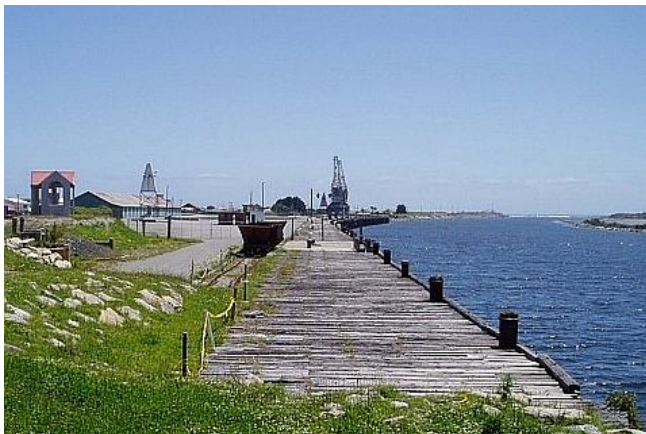
**Figure 5.1: Port of Greymouth**

*Photo of the Port of Greymouth looking towards the mouth of the Grey River.*
